# MERIAM HOUSE

Minute Man National Historical Park  
Concord, Massachusetts

## Historic Structure Report

Barbara A. Yocum, Architectural Conservator  
Historic Architecture Program, Northeast Region  
National Park Service  
Lowell, Massachusetts

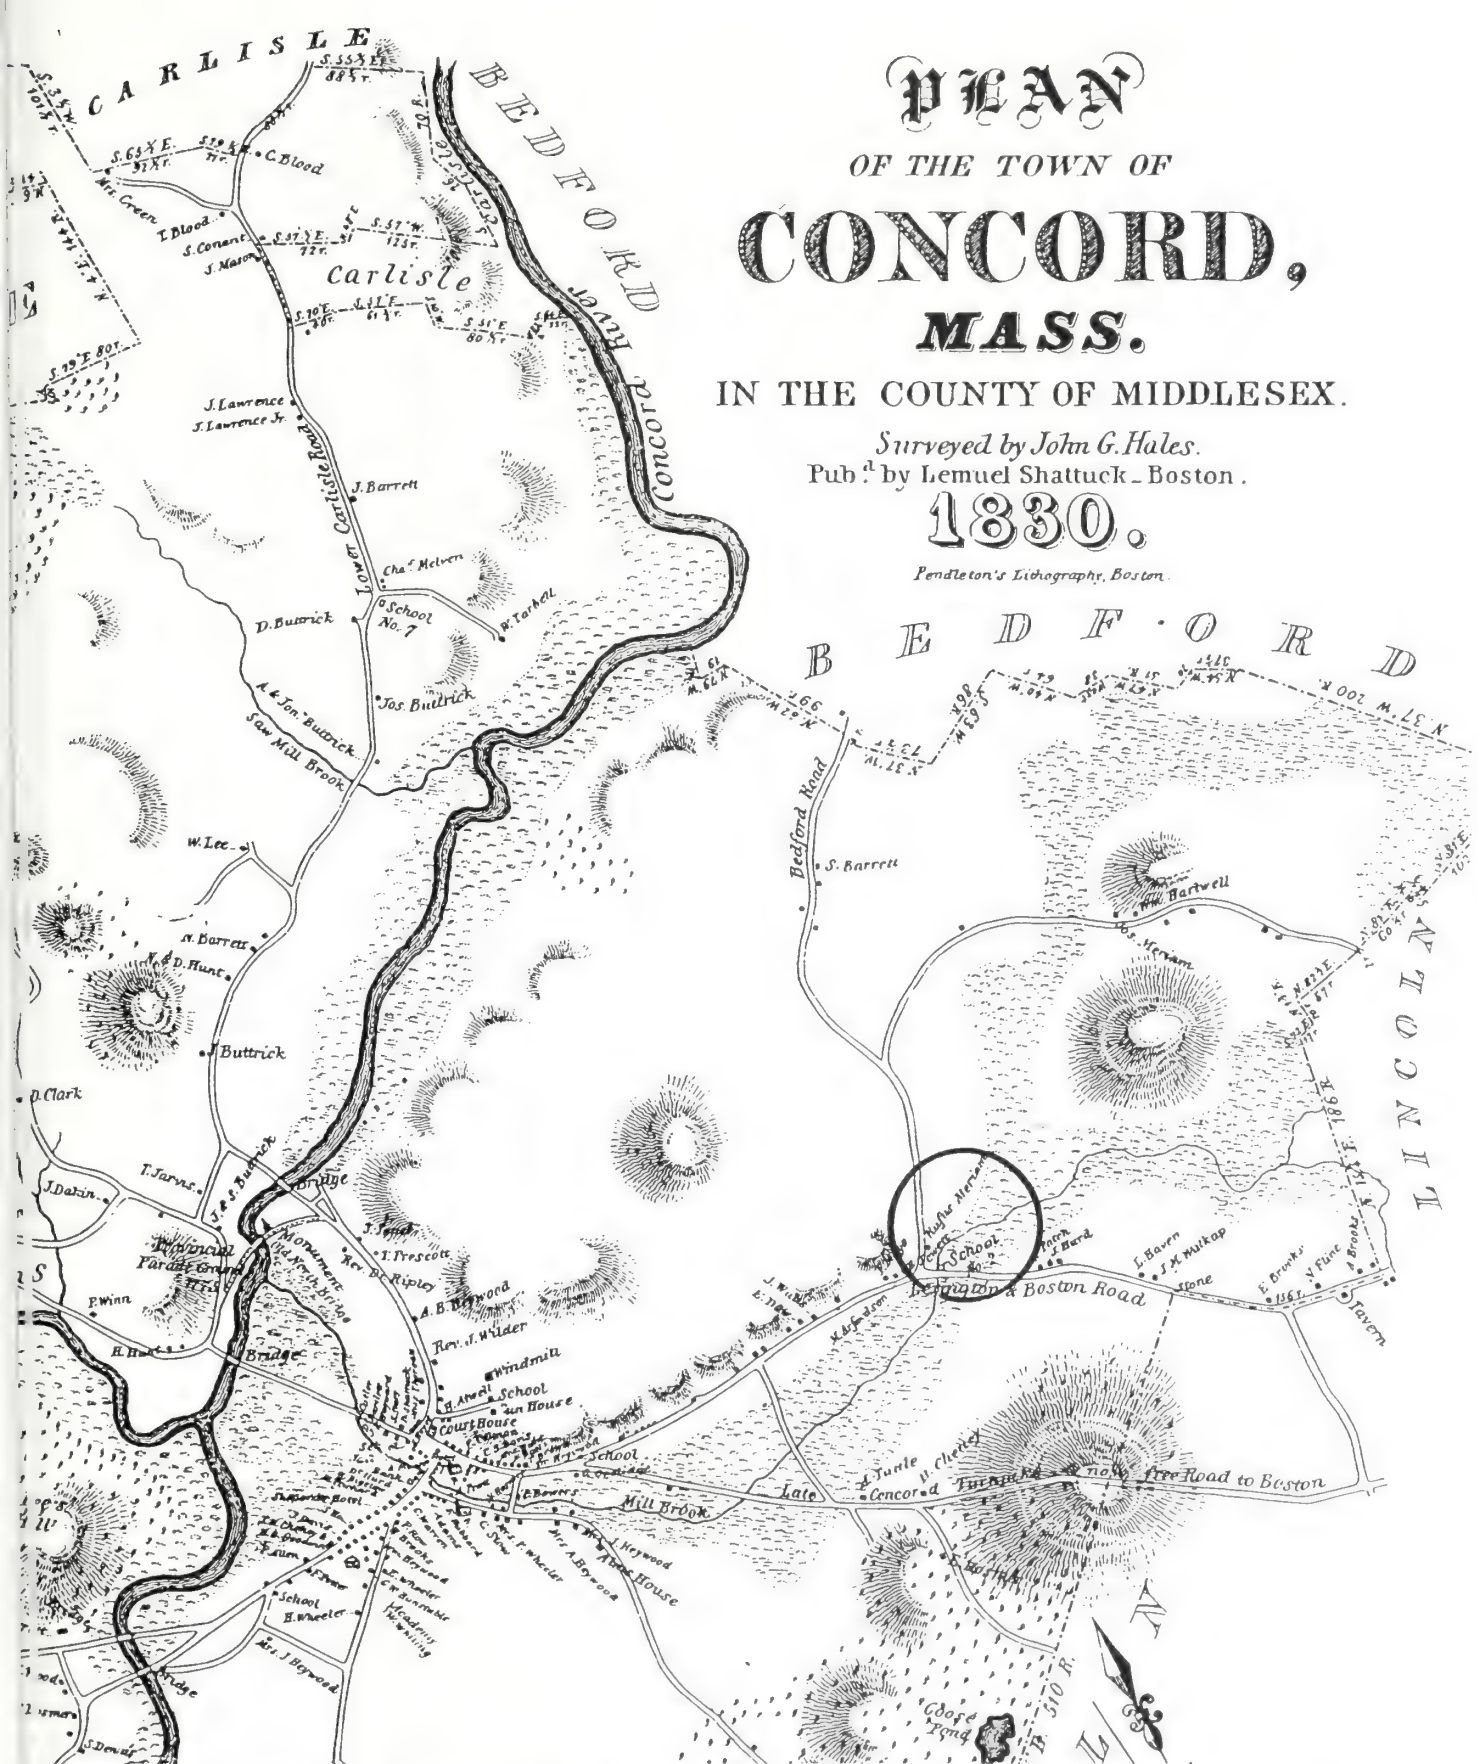
Figure 1. Detail of the 1830 "Plan of the Town of Concord, Mass." showing the Rufus Meriam house and School No. 2.

beginning in 1832, even though the official conveyance did not occur until 1834.<sup>95</sup> In addition, the name "Rufus Meriam" appears next to a square designating the Meriam House on the John G. Hales map of Concord dated 1830 (fig. 1).

The old house was most certainly gone by 1830, based on the map by John G. Hales that shows only two structures at Meriam's Corner: the house of "Rufus Meriam" on the Bedford Road, and "School No. 2" on the Lexington & Boston Road, just east of the Mill Brook (fig. 1).

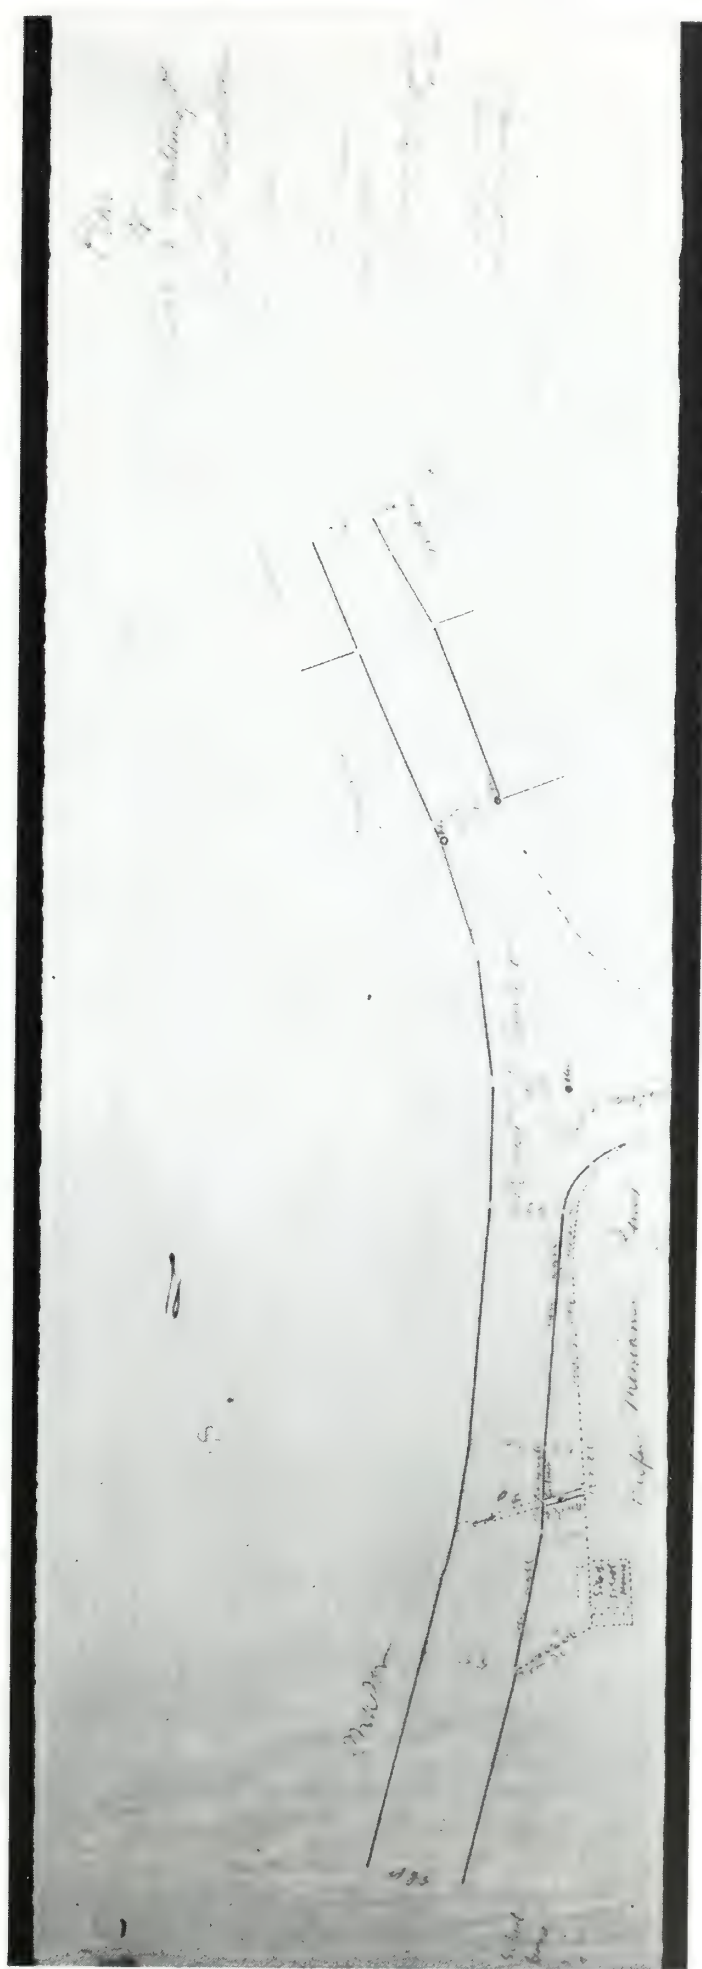
Figure 3. Final "Plan of the Road & Watering Place of the East Quarter School House." Surveyed by Henry D. Thoreau, Nov. 9, 1855.

Only one view of this schoolhouse exists, in plan form, in a survey by Henry David Thoreau dated 1855. There are two versions of the plan, one being a site sketch dated June 26 (fig. 2), and the other being a more final version without the survey lines dated November 9 (fig. 3). The "School House" is shown on the east side of, and not far from, the "Brook." The schoolhouse faces south, with a small front "Porch" and a detached "Shed" on the east side. The main body of the schoolhouse is roughly square, measuring approximately 25 feet wide by 20 feet deep, as scaled on the plan.<sup>70</sup>

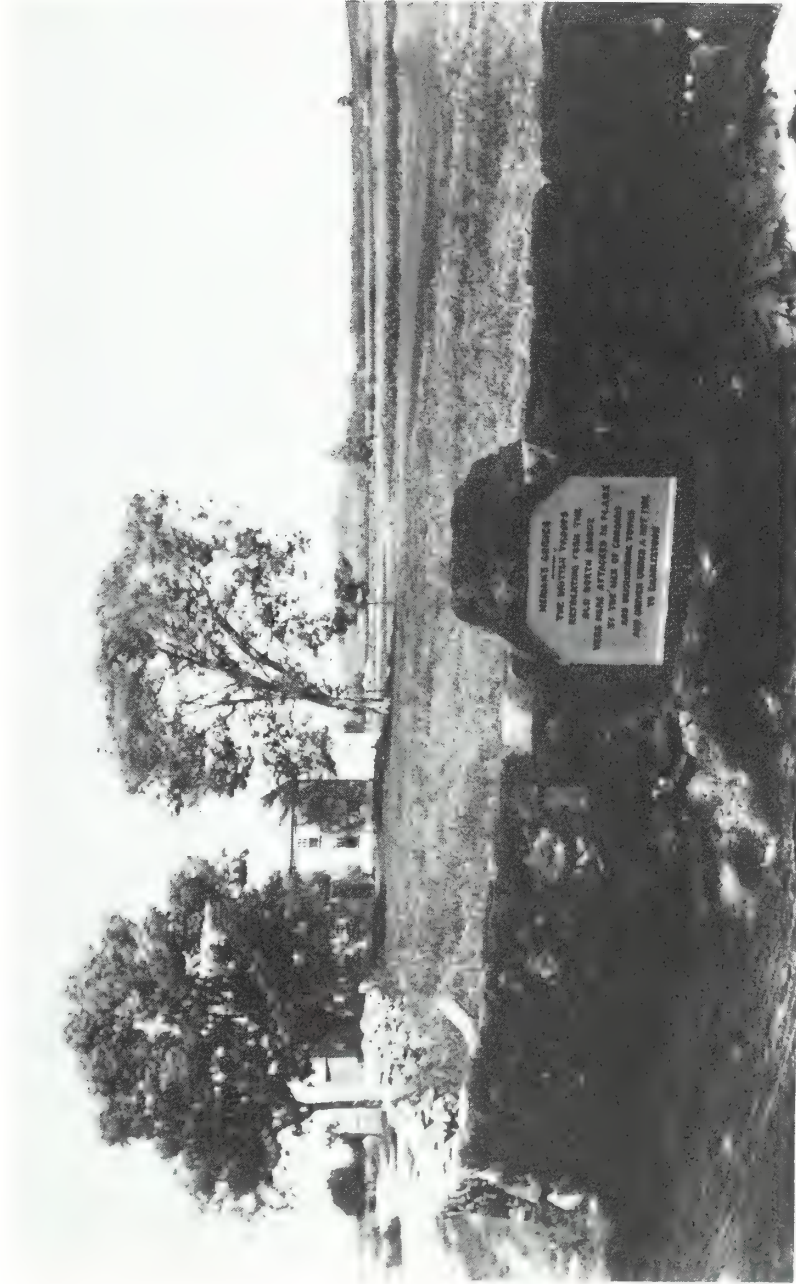
**Figure 5.** Earliest-known exterior view of the Meriam House, taken after the memorial stone was installed in 1885, and before the barn was demolished sometime between 1898 and 1899.

At some point, a small one-story shed addition was built at the east end of the north wall of the circa-1810 kitchen addition. This addition, which exists today, may also have been built circa 1820. The new addition most likely included an attached carriage shed on the east side, which can be seen in the earliest photograph of the house taken sometime between 1885 and 1898 (fig. 5).<sup>90</sup>

The house at Meriam's Corner became a popular subject for photographers after the installation of the memorial stone. The most common view shows the stone in the foreground and the Meriam House in the background. The earliest-known photograph of the house, believed to have been taken sometime between 1885 and 1898, is such a composition (fig. 5).

An early barn existed in 1806 (and perhaps as early as 1775) on the east side of Old Bedford Road, according to the probate documents of Ephraim Meriam.<sup>121</sup> Furthermore, the earliest photograph of the house shows what appears to be a barn behind the Meriam House (fig. 5). The Burkes' granddaughter, Alice Burke Hargrove, also recalls being told that the "old barn" had been on the north adjacent lot, although she has no personal memory of it.<sup>122</sup>

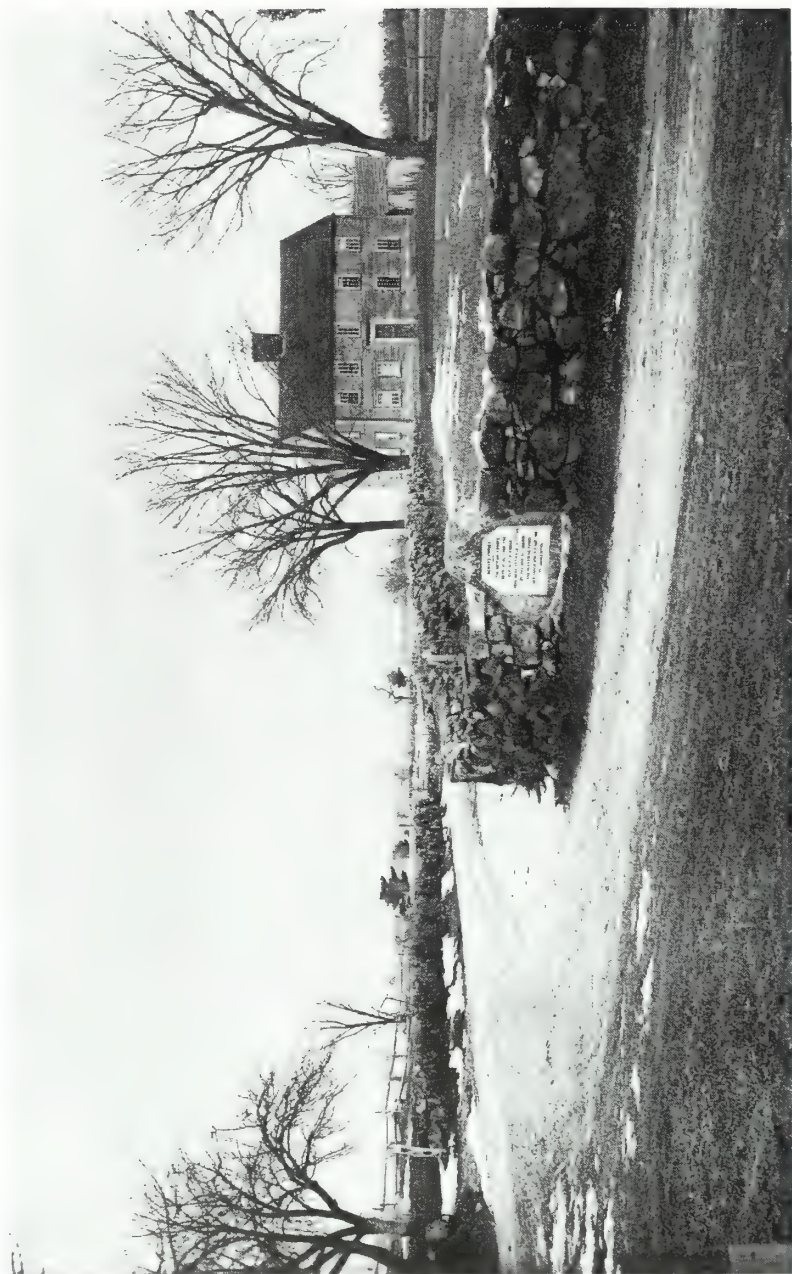
**Figure 6.** Meriam House exterior, view looking northeast, circa 1899.

Information on the historic gutter system is virtually nonexistent, except for two early photographs dated circa 1899 (figs. 6, 8). These show one complete downspout on the front, west side of the house, and a partial (upper) downspout on the east side. This indicates that a gutter existed on the front of the house, although no details of it are visible in the photographs. Furthermore, all physical evidence of the gutter was probably destroyed when the roof was reconstructed after the circa-1925 fire.

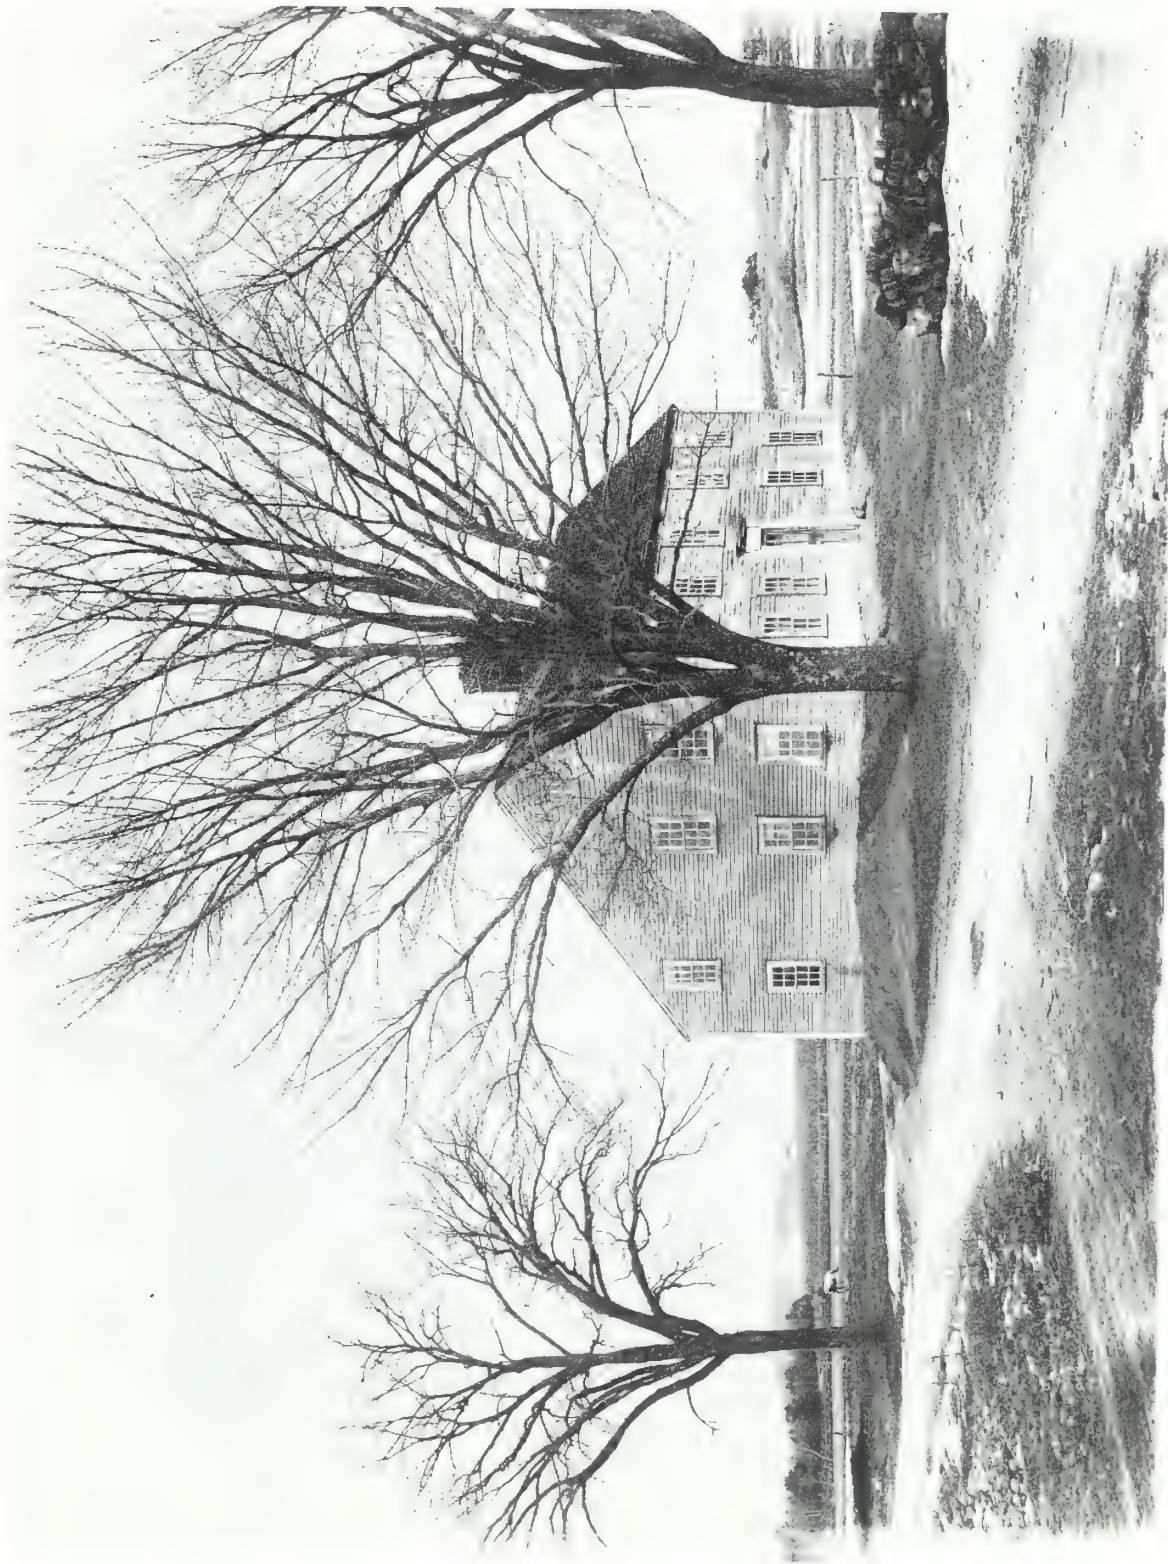
Figure 7. Meriam House exterior, view looking northeast, circa 1899.

Unlike W-301, early photographic documentation exists for this attic window. The earliest photograph, dated circa 1899 (fig. 7), shows a smaller window with a four-light sash. Whether or not this window was original to the circa-1725 addition could not be ascertained, however. The existing window with its six-light sash is larger than that shown in the early photograph; it therefore appears that the window opening was enlarged when the gable end was rebuilt circa 1925.

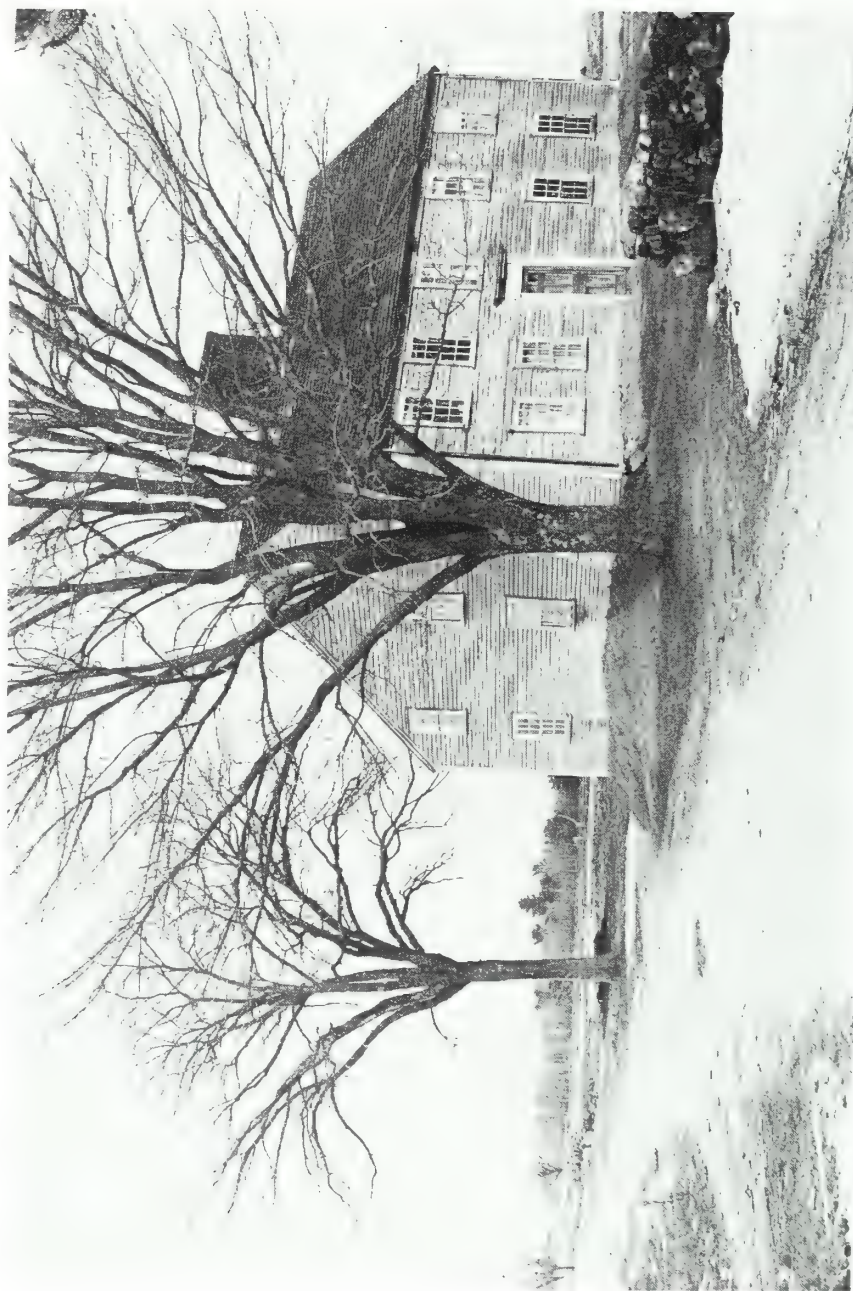
Figure 8. Meriam House exterior, view looking northeast, circa 1899.

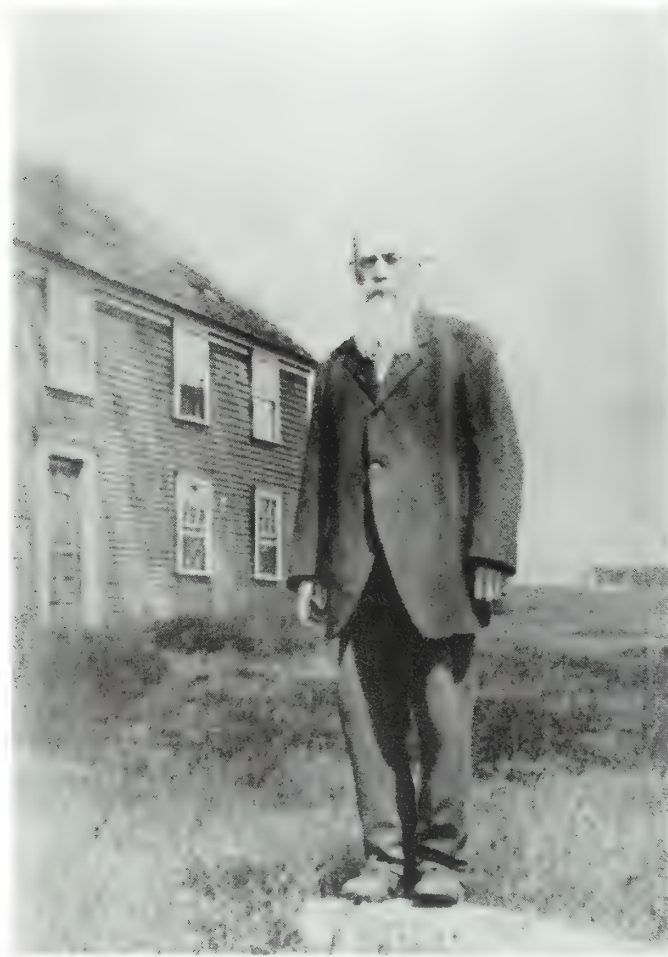
**Figure 15.** Thomas Burke in front of the Meriam House,  
circa 1910.

The new doorway architrave was plain compared to the earlier classical surround, with a simple pediment at the top. The new door was glazed and paneled, with four panels below the glass and two panels above it. A clear view of the altered doorway was captured in a photograph of Thomas Burke dated circa 1910 (fig. 15).

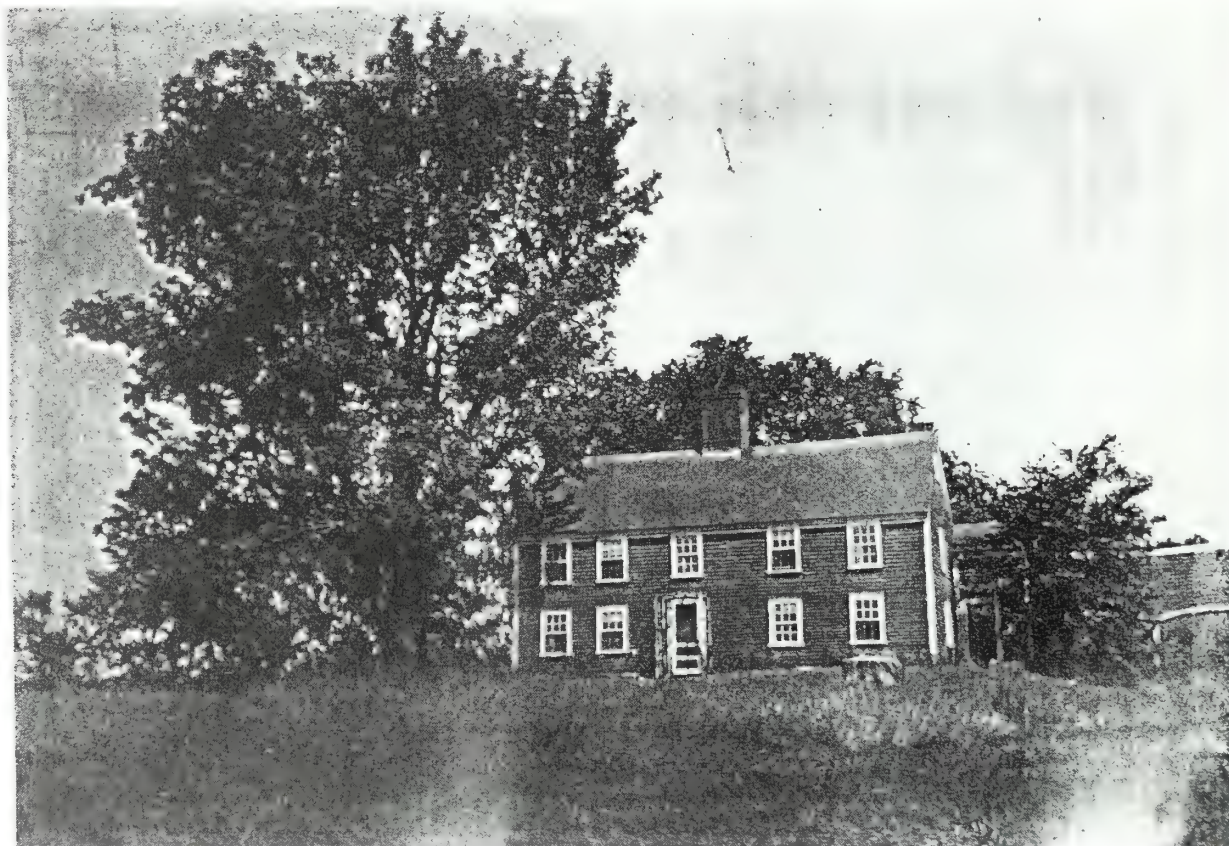
**Figure 17.** Meriam House, view looking northwest, circa 1937.

It is not known if a window was in this location circa 1705, or was added later. One existed here by circa 1937, based on a photograph of that date that shows it at an oblique angle (fig. 17). Unfortunately, no details of the window are visible.

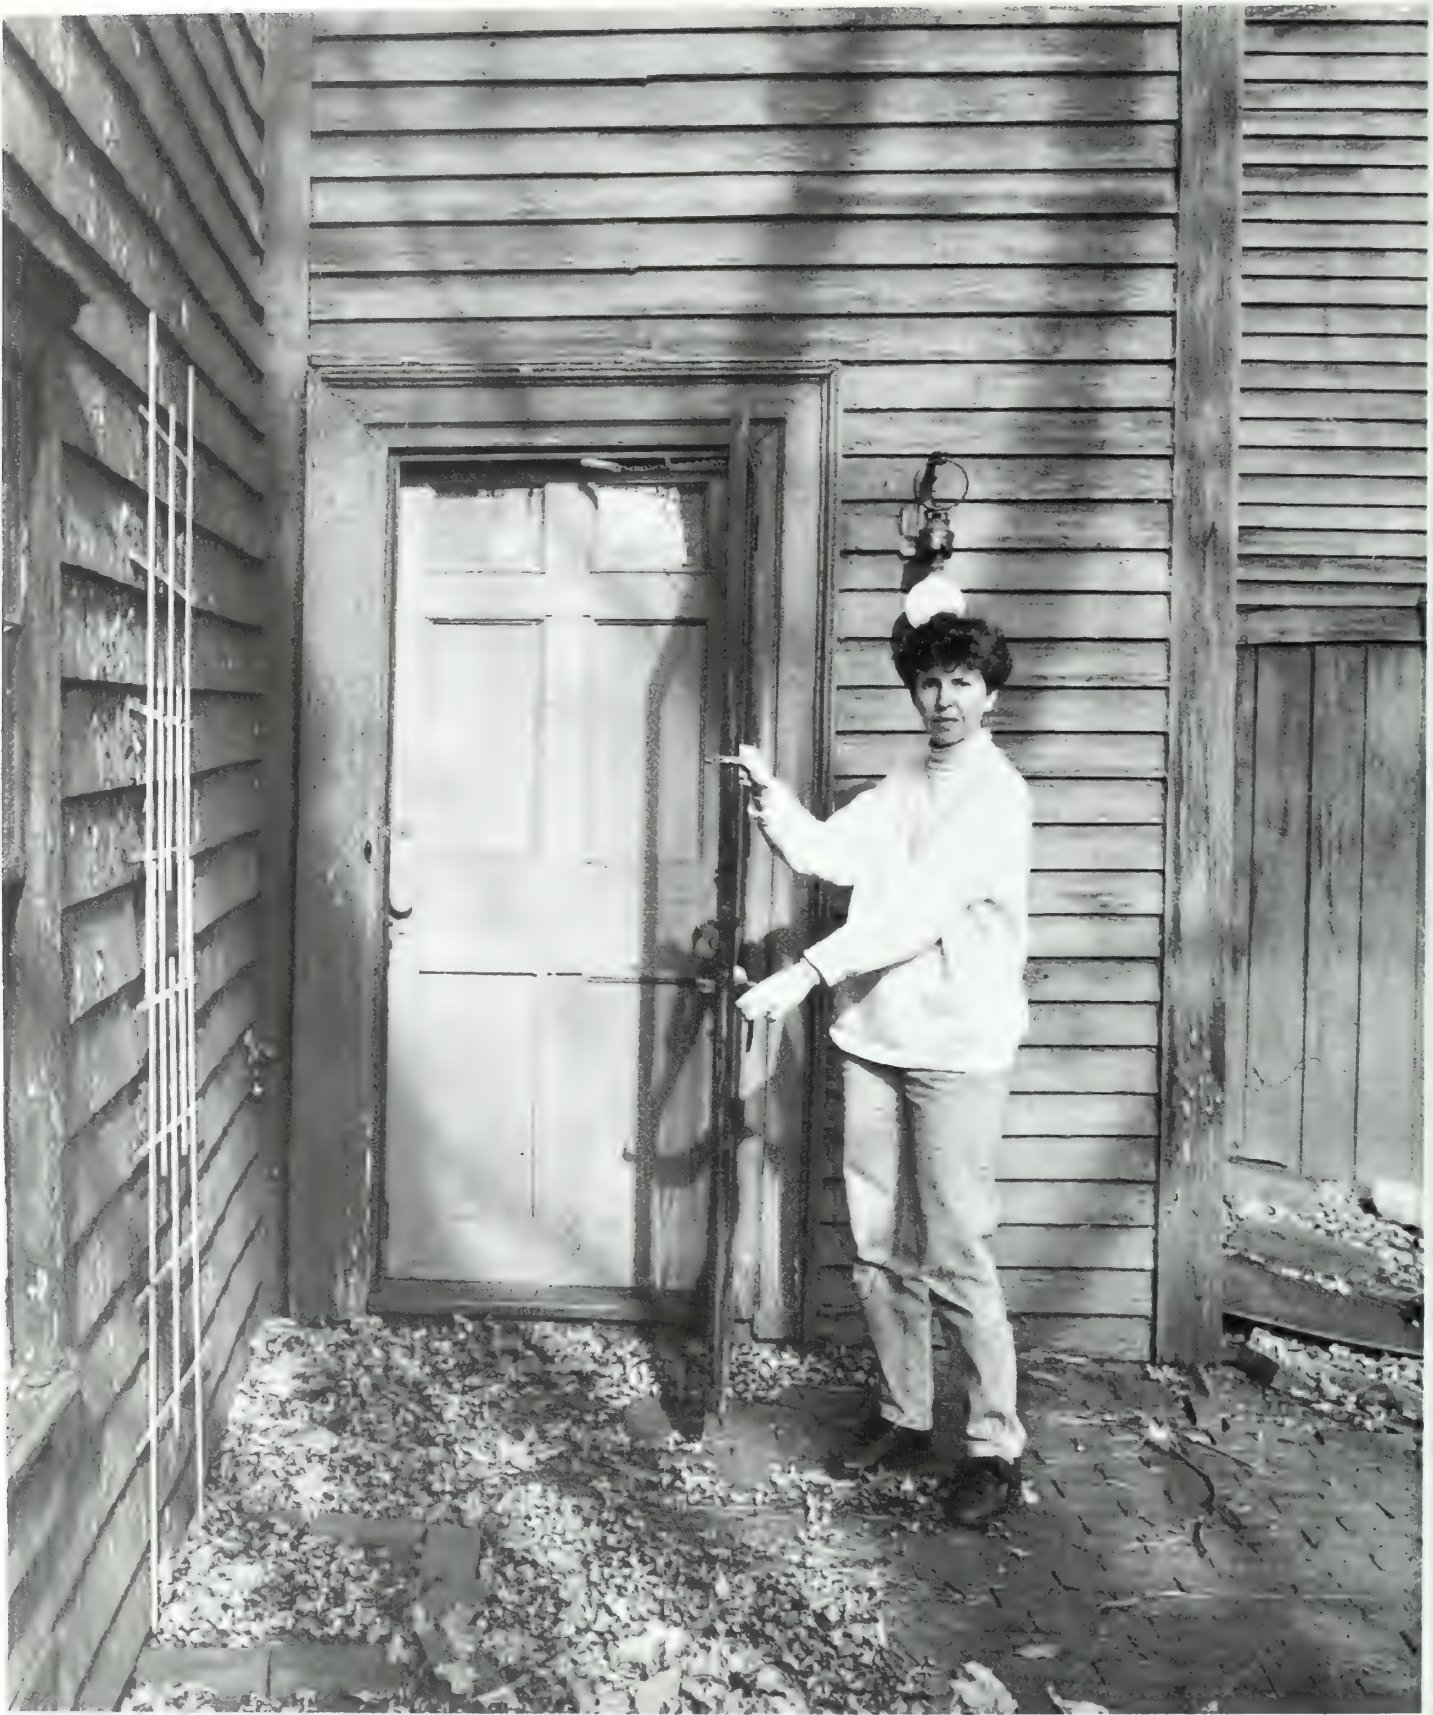
Figure 24. Meriam House, detail of circa-1820 side door (1993).

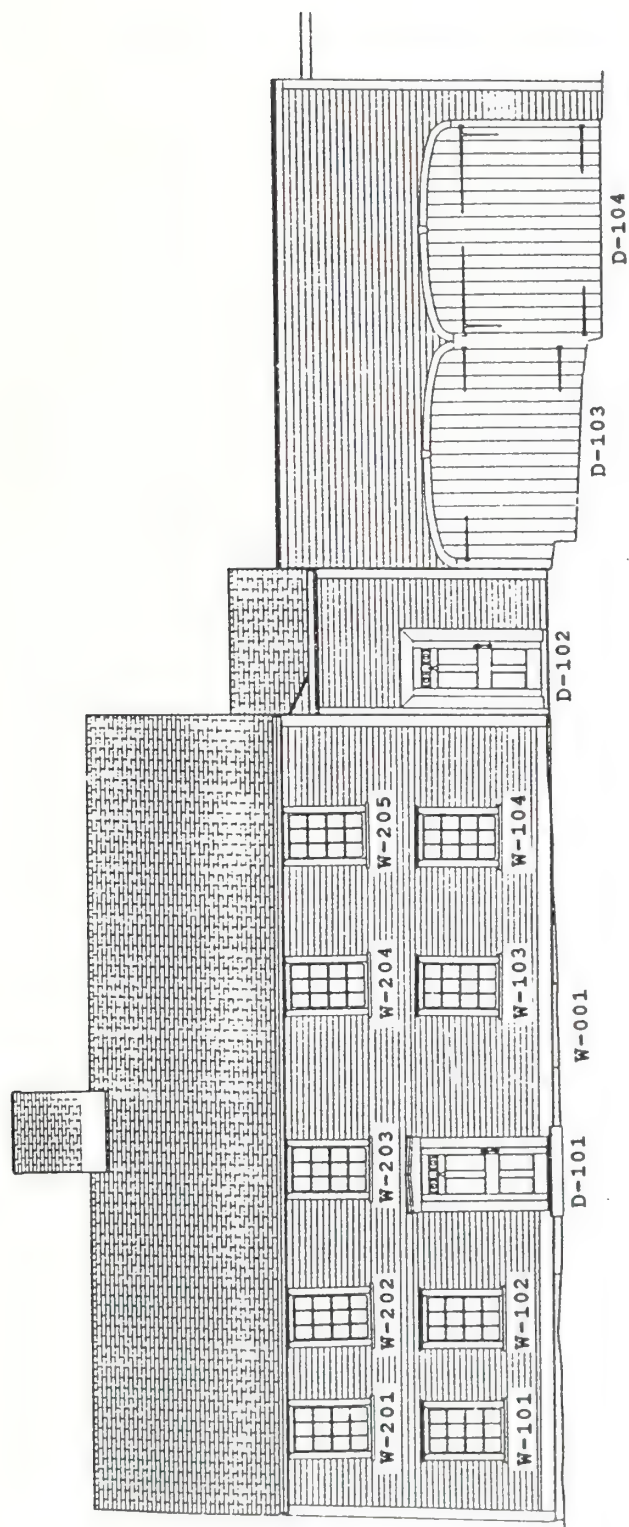
Figure 29. Meriam House, exterior south elevation (1993).

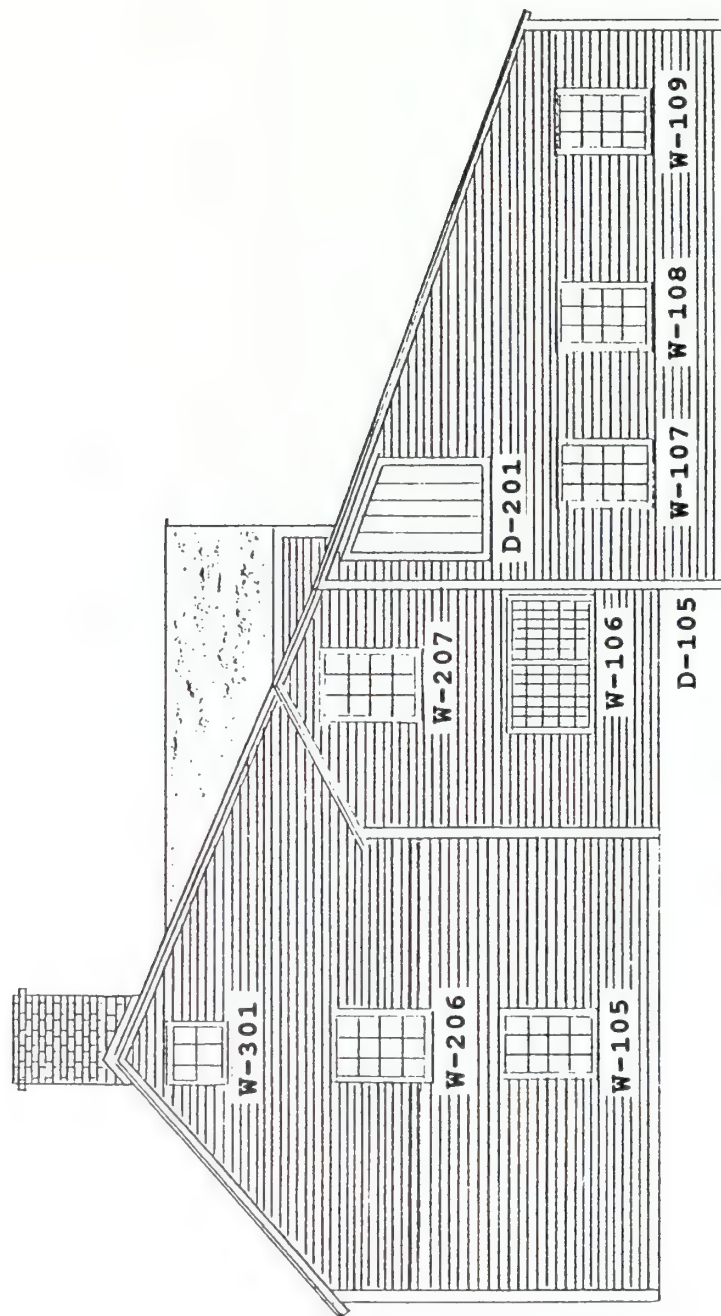
Figure 30. Meriam House, exterior east elevation (1993).

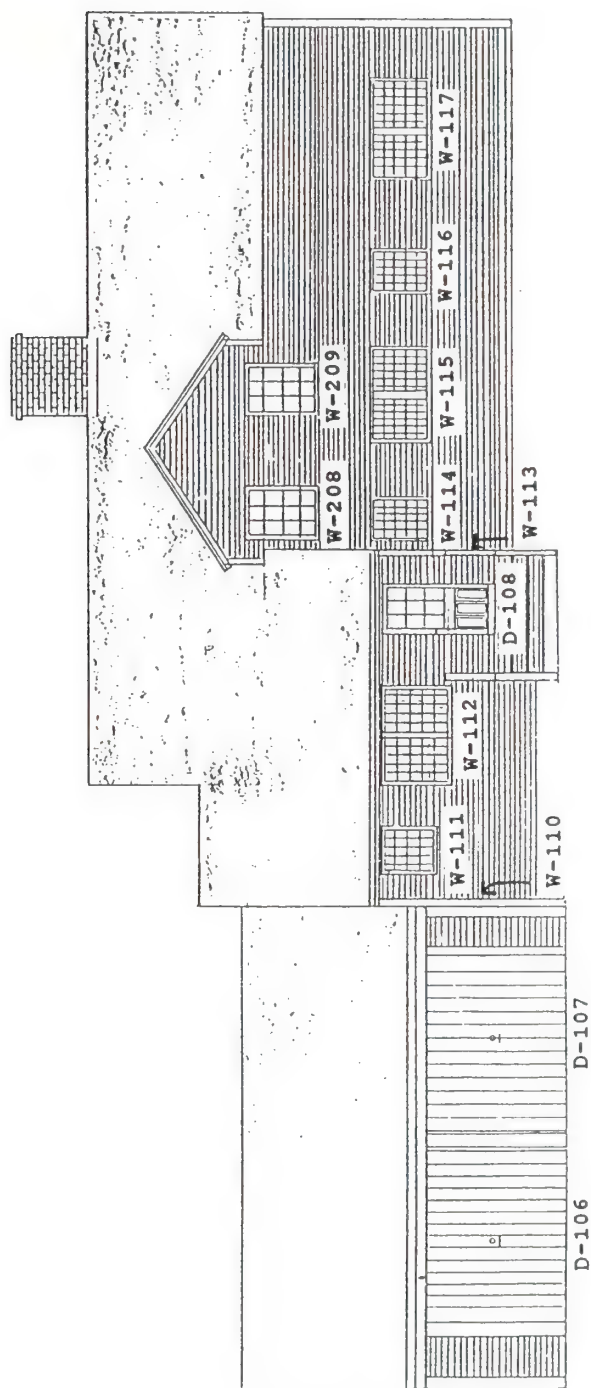
Figure 31. Meriam House, exterior north elevation (1993).

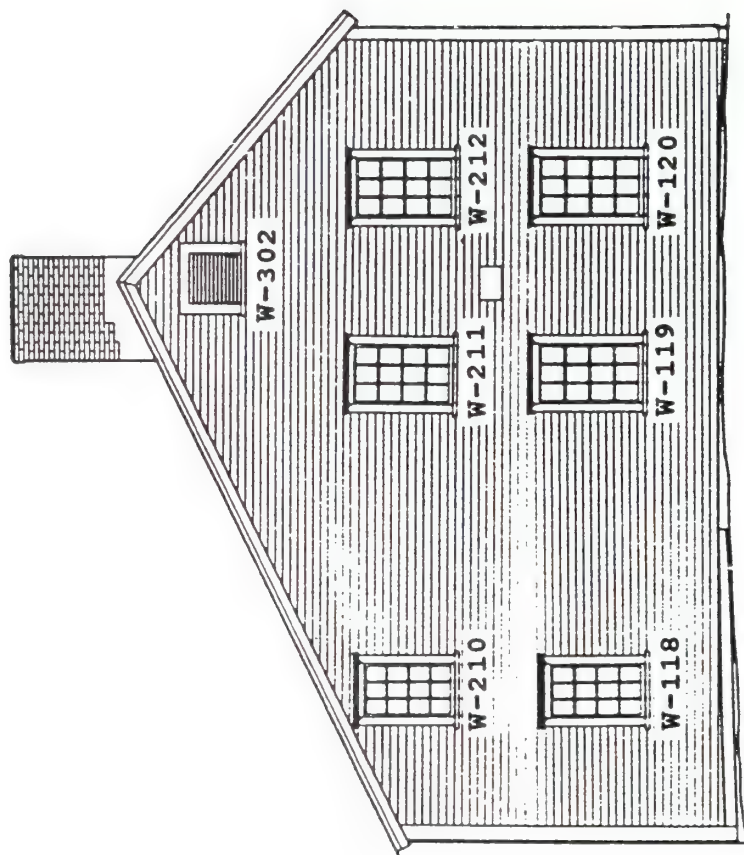
Figure 32. Meriam House, exterior west elevation (1993).

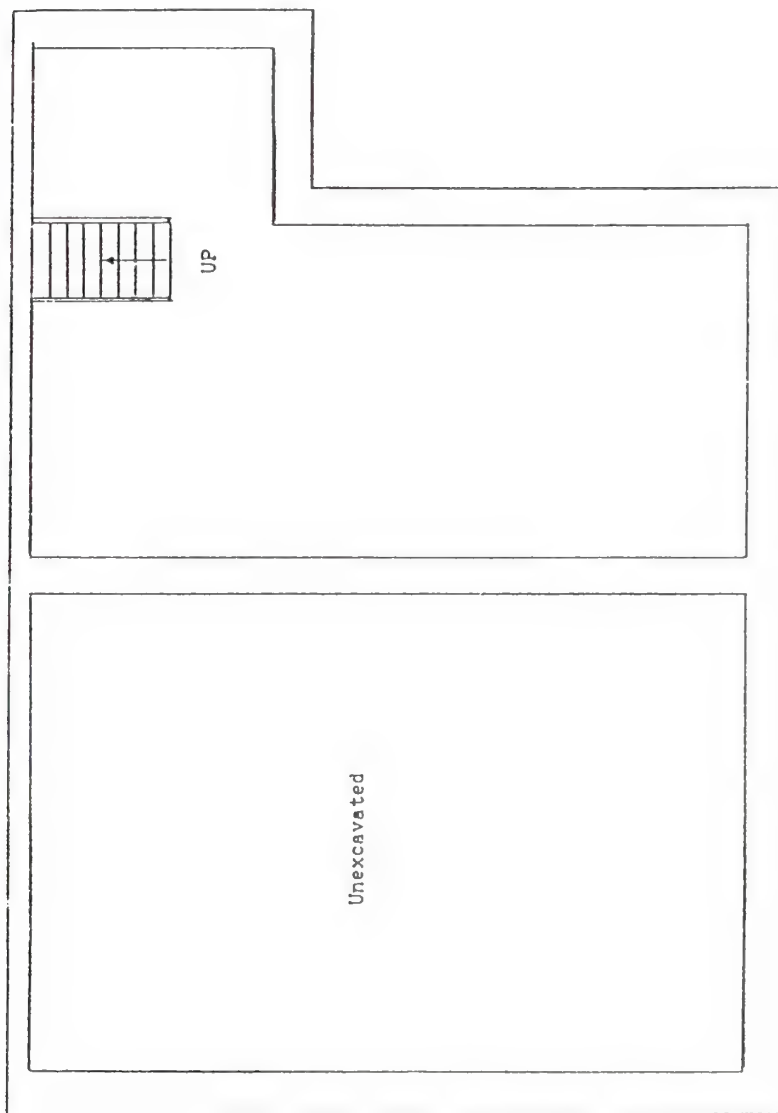
Figure 33. Meriam House, cellar floor plan (1993).

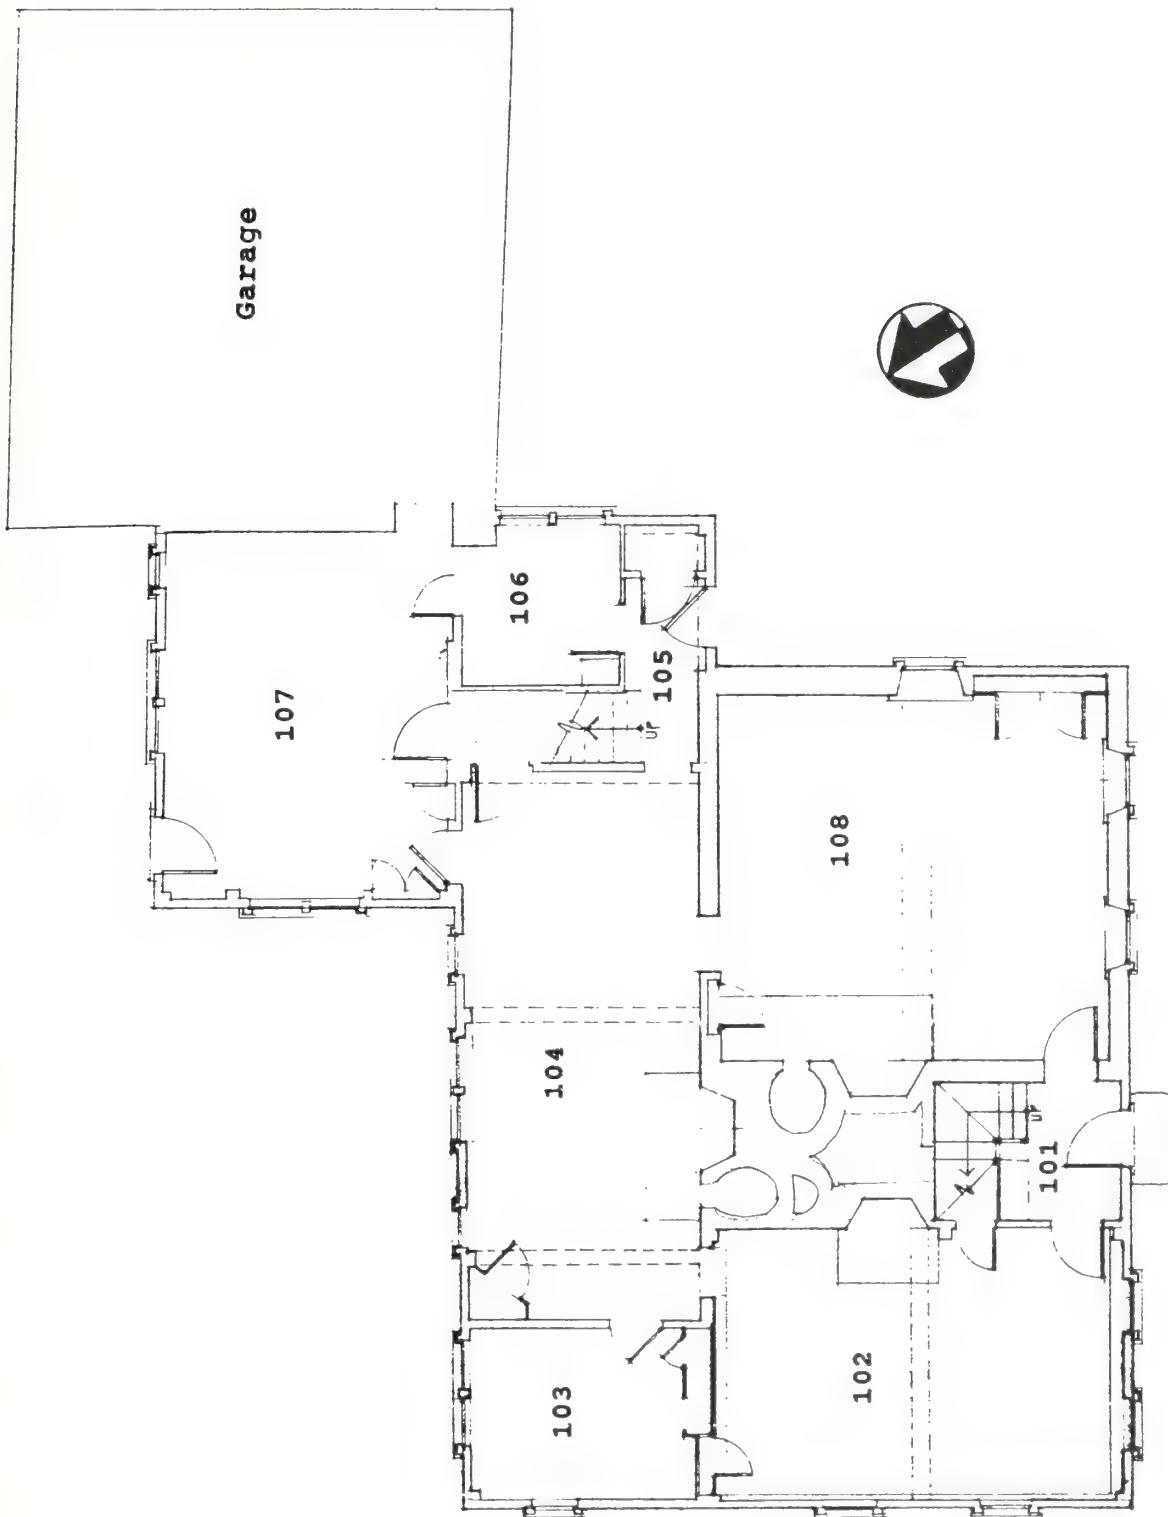
Figure 34. Meriam House, first-floor plan (1993).

The architectural descriptions of the interior of the house are discussed by room, beginning with the cellar and ending with the attic. As mentioned at the beginning of this chapter, each room in the first and second stories has been assigned a number (figs. 34, 35). The reason for this is to simplify discussions of the rooms, because some of the room names and uses have changed over the years.<sup>12</sup>

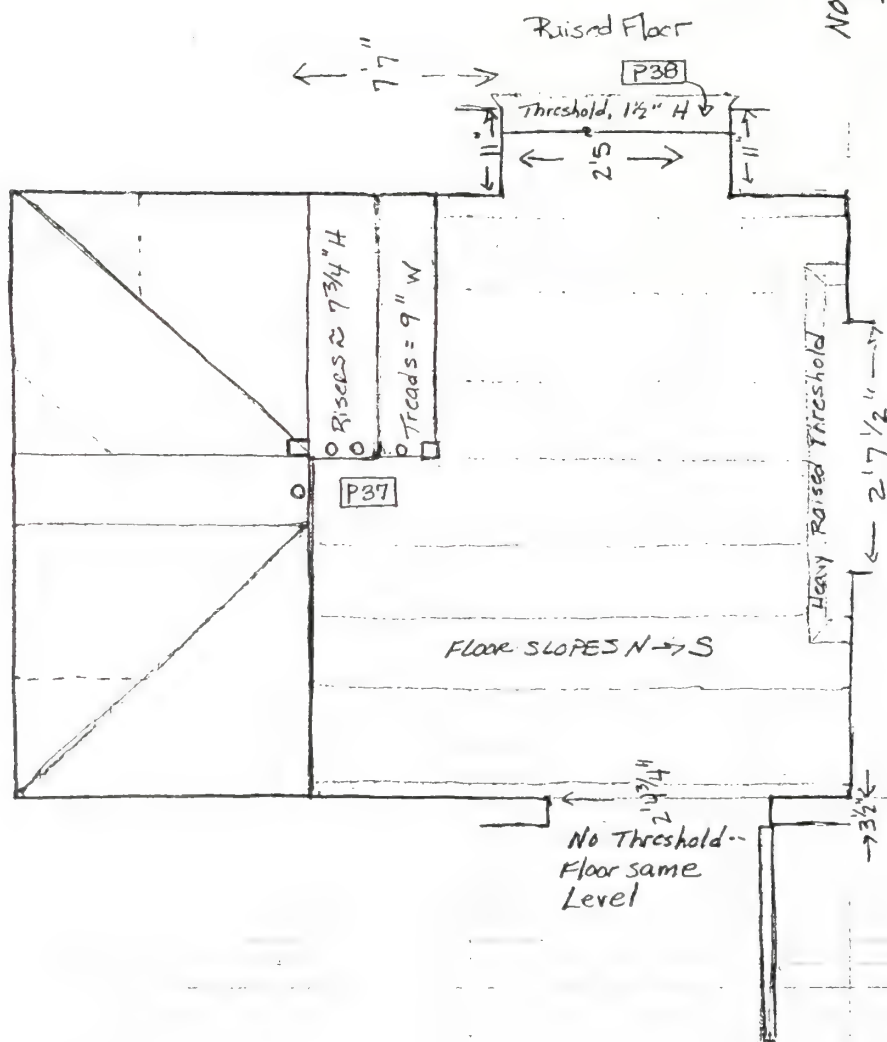
MIMA: MERIAM HS.  
RM 101, FLOOR  
Aug. 9, 1993, B. Yocum  
SCALE: 1/2" = 1'0"

NOTE: Floorboards ONLY  
Are Painted Yellow.  
Treads are UNPAINTED.

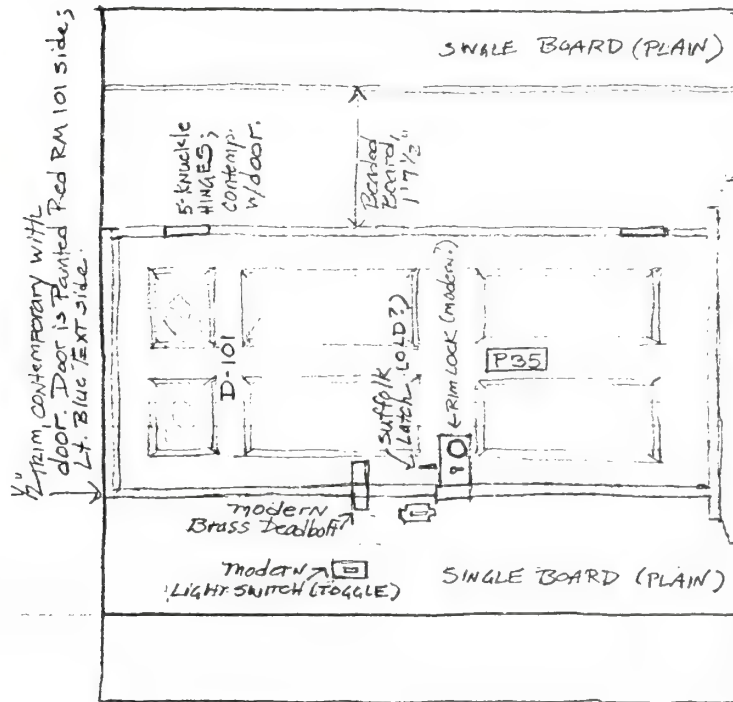
MIMA: MERIAM HS  
 RM 101, SOUTH WALL  
 Aug. 9, 1993; B. Yacum  
 SCALE: 1/2" = 1'0"

Hand-wrought NAIL HEADS  
 VISIBLE IN WALL PANELING;  
 ATTACHED WITH MODERN CUT  
 NAILS; empty nail holes  
 WITH SQUARE PROFILE INDICATE  
 REUSE. D LOOKS HAND-PLANED.

Door is 1950's Reproduction?  
 Recessed Panels, Both Sides.  
 Measures: 6' 3 3/4" H

Wall depth 9 1/2"  
 doorway = 11"
